Cape Hatteras, NC

Relocation of Cape Hatteras Lighthouse

Services Performed:

- Shore Protection
- Foundation Design
- Structural Analyses
- Expert Assistance

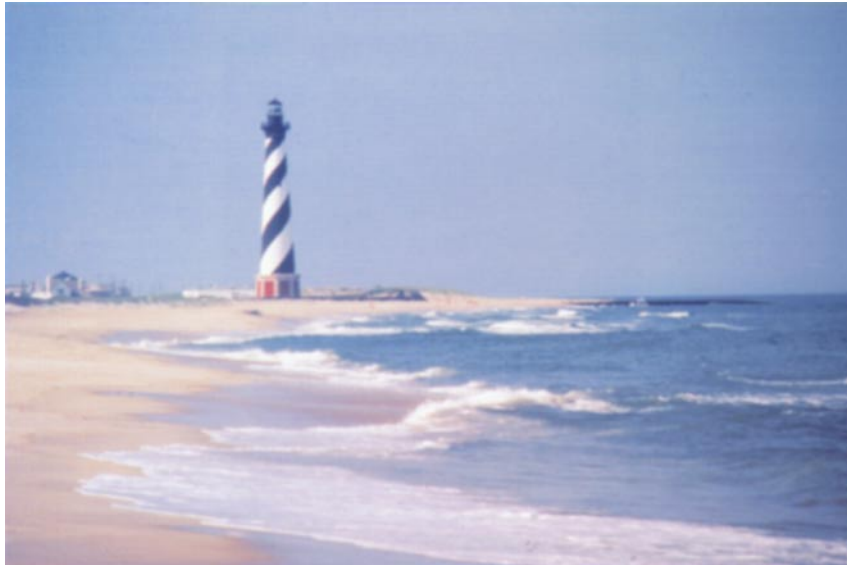
Cape Hatteras Lighthouse.

The lighthouse is of brick construction, founded on a timber raft just below the ground water line. Extensive investigations have been made as to the best way of saving this National Historic Monument. Concepts included a massive stone and concrete revetment, and, alternatively, dismantling and re-erecting the lighthouse inshore.

The moving involved reinforcing and tying together of the brick structure, insertion of heavy girders underneath the

tower, cutting it loose from its timber raft, and jacking it up.

The lighthouse weighed 2500 tons and has a high center of gravity. Stability will have to be provided by external framing-

Then the tower was slid along a prepared skidway to its new location and jacked down onto its new pile-supported foundation.
