Wellwood Reef Restoration Molasses Reef, Key Largo, FL

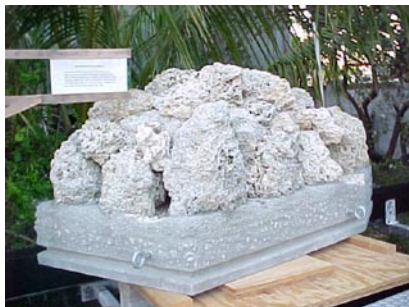
Reef restoration module.

The work required the placement of Reef Restoration Modules. The modules were placed in the empty gaps on the reef floor in order to stop the

spreading of further damage. Gerwick developed a special underwater concrete mixture that was used to keep these modules in place. The concrete had to perform superbly with regard to:

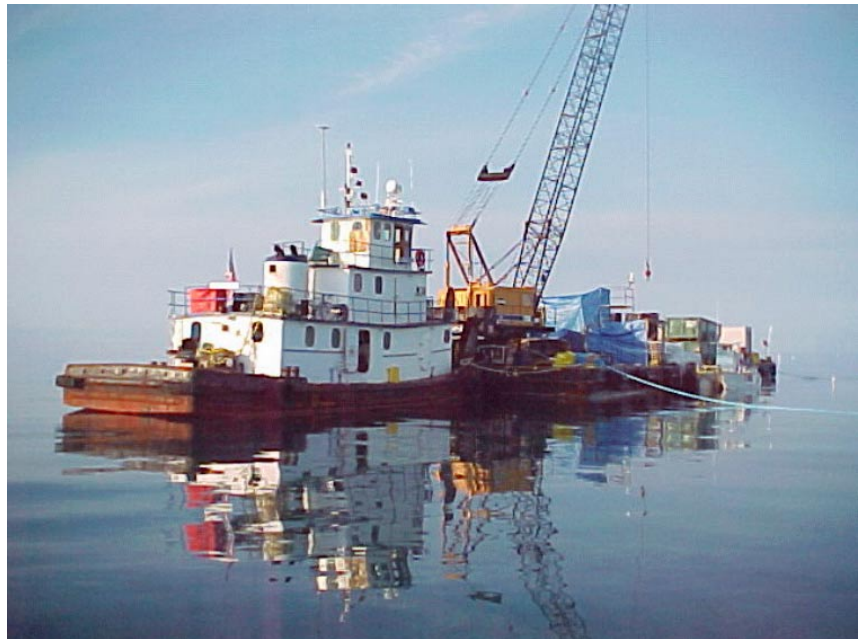
Crane barge installing reef restoration modules at operation site.

The water at the worksite was 15 to 20 ft deep, and the entire operation was performed off a working barge.
