Sheraton Gateway Hotel Planter Terrace Deck, San Francisco, CA

San Francisco Airport Sheraton Gateway Hotel.

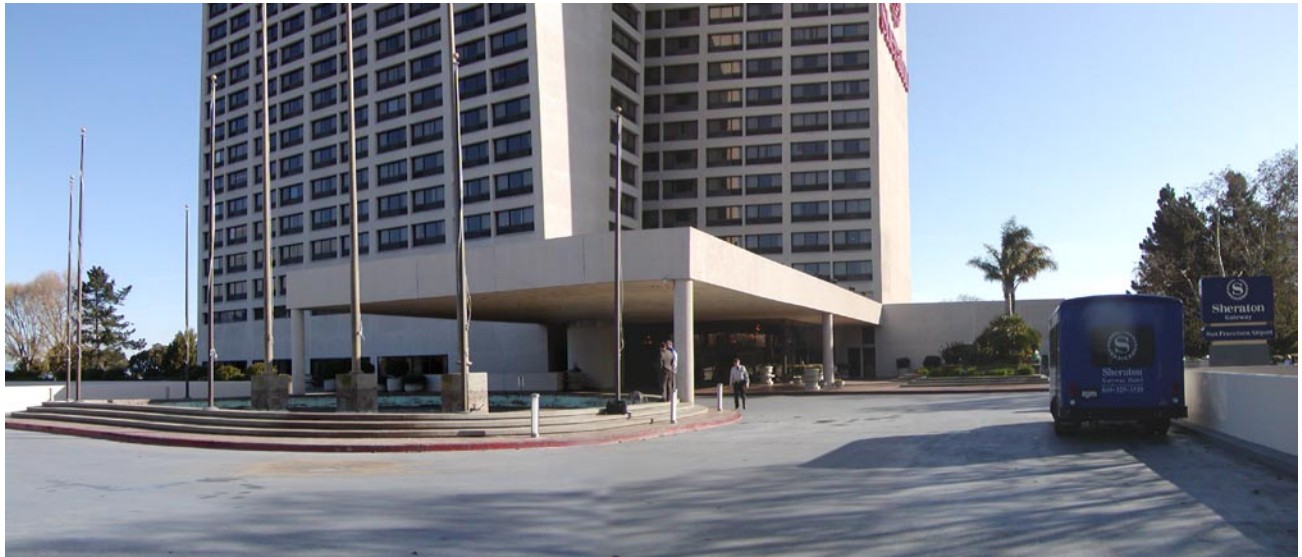
Ben C. Gerwick, Inc. was retained to conduct an investigation to determine the cause of the structural failure of the 8 1/2" post tensioned concrete slab at the planter terrace of the Sheraton Gateway Hotel at the San Francisco Airport. The hotel was originally designed in 1981 and constructed in 1983.

The failures in the slab occurred at columns inside the planter area which is approximately 60 ft in diameter. At the time of failure the planter was filled with soil and landscaping, which was removed after the failure. Outside the planter area is the hotel drop-off point, turn around area and access to parking below the hotel and planter area.
